Manhole Inspection Summary

Manhole # S13CC1030MH

Insp Date: **6/20/07 8:18 AM**

Location Address: **2900 KEYWORTH AVE** Cross Street: **TOWANDA AVE**

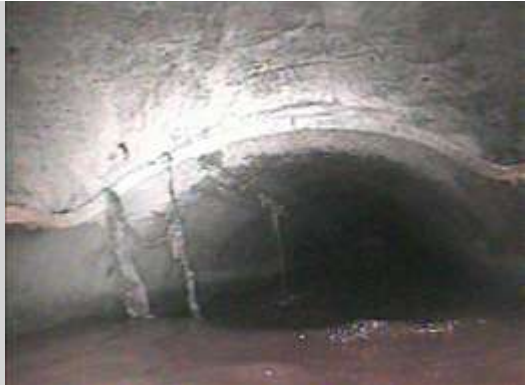
12 O'Clock Outflow

24 in. Circular Gravity Sewer
Pipe Out @ 12 O'Clock

Pipe Height: **24** (in.) Rod and Bar (Angled)
Pipe Material: **PVC** ☐ Pipe Lined
Invert Depth: **17.41** (ft.) Flow Characteristics: **Fast**
Deposits: ☒ None ☐ Mud ☐ Sludge ☐ Debris ☐ Grease
Silt Depth: (in.) Deposits Extent:
Infiltration: **None** Pipe Seal Cond: **Sound**

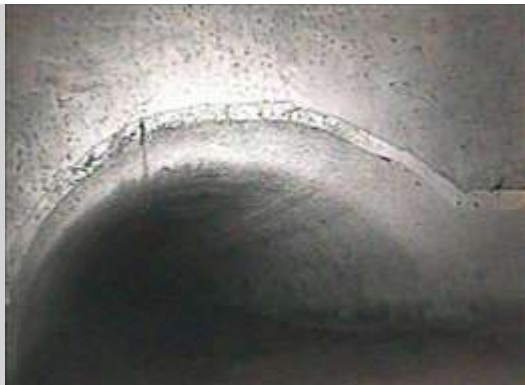
5 O'Clock Inflow

24 in. Circular Gravity Sewer
Pipe In @ 5 O'Clock

Pipe Height: **24** (in.) Rod and Bar (Angled)
Pipe Material: **PVC** ☐ Pipe Lined
Invert Depth: **17.36** (ft.) Flow Characteristics: **Fast**
Deposits: ☒ None ☐ Mud ☐ Sludge ☐ Debris ☐ Grease
Silt Depth: (in.) Deposits Extent:
Infiltration: **None** Pipe Seal Cond: **Sound**
